CALSPAN ON-SITE AIR BAG/CHILD FATALITY INVESTIGATION

CALSPAN CASE NO. 96-15

VEHICLE - 1995 MAZDA PROTÉGÉ'

LOCATION - OHIO

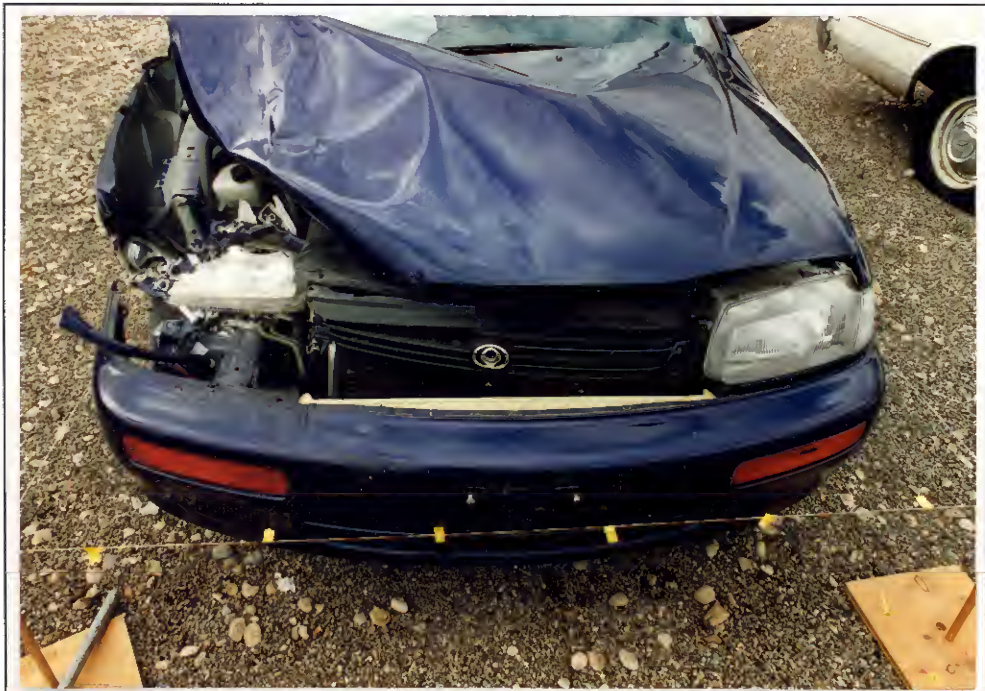
The right frontal area of the Mazda struck the left rear bumper of the Monte Carlo. Due to the pre-impact braking of both vehicles, the front bumper of the Mazda underrode the rear bumper of the Monte Carlo. The Mazda sustained direct contact damage which began 16.3 cm (6.4 in) right of center and extended 56.1 cm (22.1 in) to the right corner. The front bumper was crushed 1.4 cm (0.5 in) at the right corner. However, the right corner of the upper radiator support panel and the leading edge of the right front fender was crushed to a maximum value of 19.3 cm (7.6 in). Crush values measured at the upper radiator support were as follows: C₁= 2.3 cm (0.9 in), C₂= 5.4 cm (2.1 in), C₃= 6.0 cm (2.4 in), C₄= 10.8 cm (4.3 in), C₅= 19.3 cm (7.6 in), C₆= 15.6 cm (6.1 in).

2. View of the frontal damage of Vehicle 1.

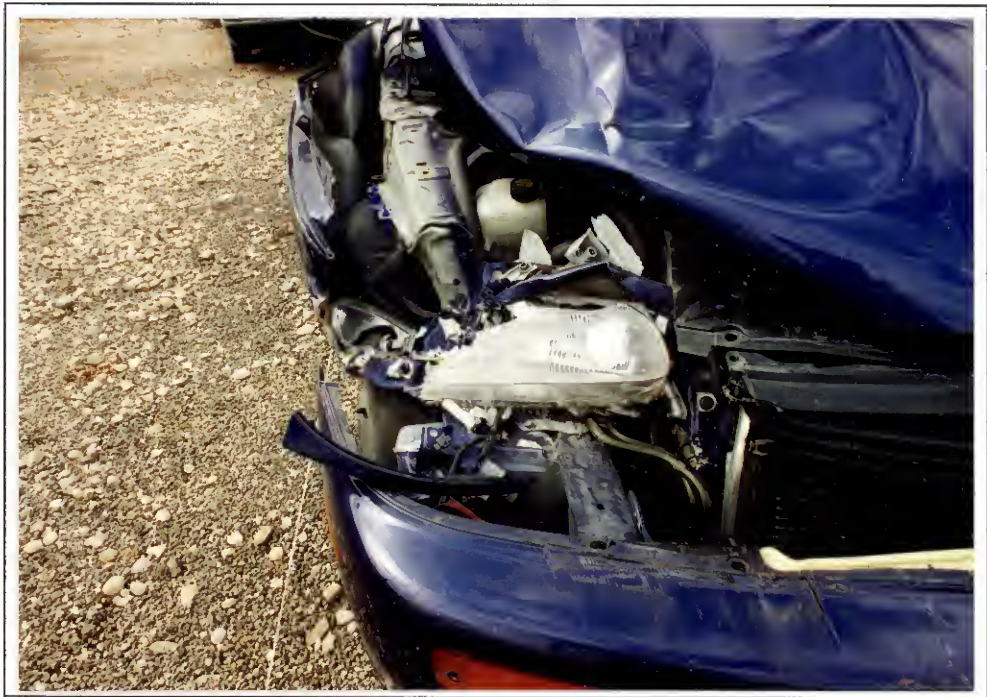
3. Close-up view of the right front damage.

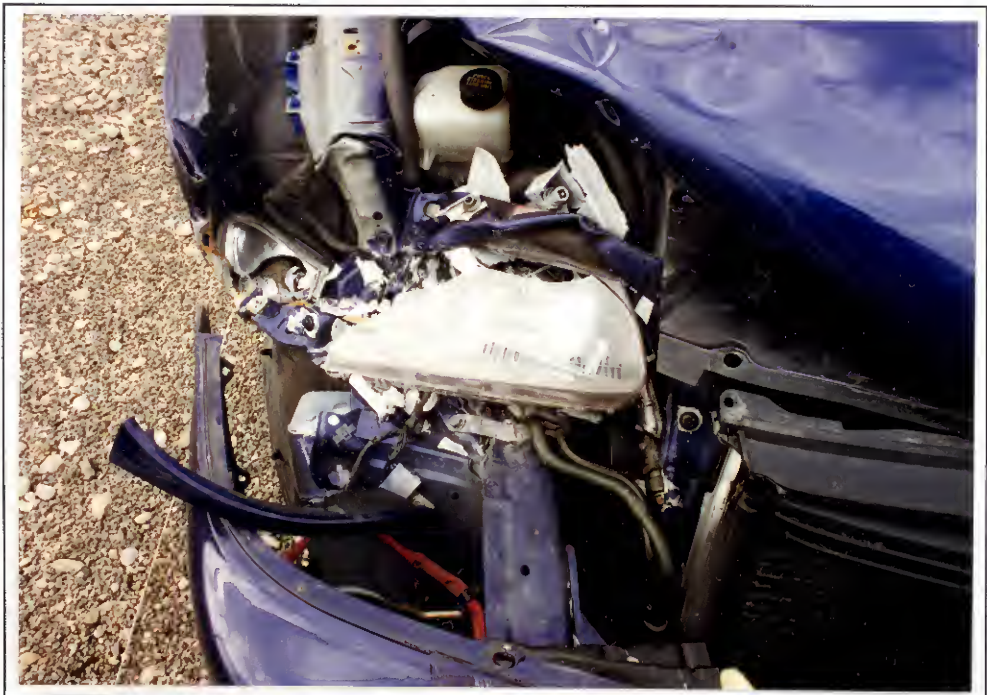
4. Close-up view of the right front damage.

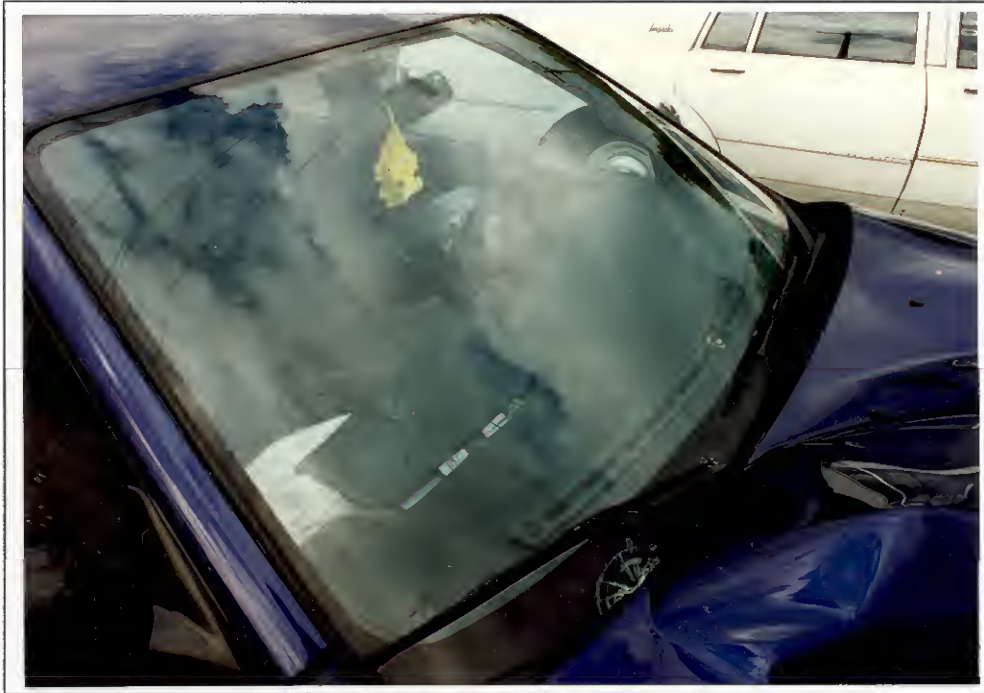
The windshield glazing was cracked in two areas. One of the spider web-type fractures was located 14.0 cm (5.5 in) above the instrument panel and 20.3 cm (8.0 in) right of center and the other was located 15.9 cm (6.25 in) above the instrument panel and 47.0 cm (18.5 in) right of center. The upper boundary of the fractures was 6.4 cm (2.5 in) below the header and extended downward to 26.7 cm (10.5 in) above the instrument panel. A vertically oriented vinyl transfer extended across the windshield between the two fractures (refer to Photograph No. 56). The transfer started 14.6 cm (5.75 in) right of center and 8.9 cm (3.5 in) above the top of the instrument panel and extended horizontally 33.5 cm (13.2 in) to the right to a point 6.4 cm (2.5 in) above the top of the instrument panel. Air bag fabric transfers on the windshield started 2.5 cm (1.0 in) left of the center and extended to the right 7.0 cm (2.75 in) inboard of the right A-pillar. The rear view mirror was canted to the left by the deploying passenger side air bag but was not damaged. An air bag transfer 5.1 cm (2.0 in) wide and 6.4 cm (2.5 in) high was noted on the right side of the back of the rear view mirror, (reference Photograph No. 60). The right sunvisor was deformed at the outboard hinge point as a result of contact by the handle of the child restraint as it was pushed upward by the air bag module flap and deploying air bag, (refer to Photograph No. 58). The passenger side air bag exhibited evidence of contact (transfers) with the back of the rear-facing child restraint. The glove box door was open at the time of the investigation.

17. View of the right side windshield fractures.

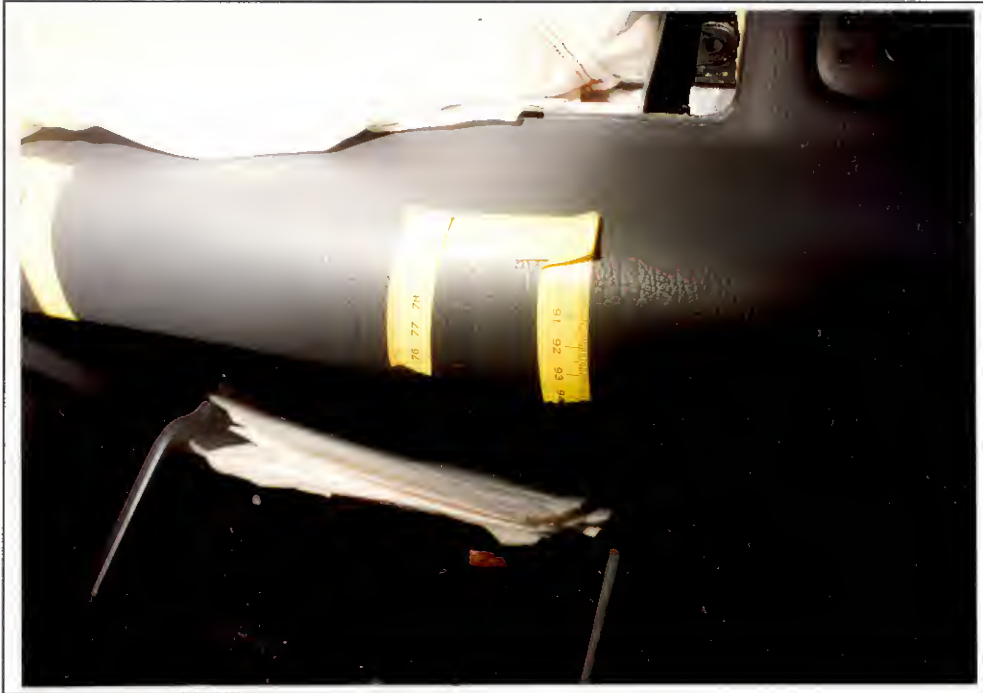
The child restraint contacted the mid instrument panel below the passenger side air bag module during pre-impact braking, scuffing the leading edge of the instrument panel in two locations. Two 5.1 cm (2.0 in) vertical contact marks from the back struts of the child restraint shell were located 21.0-22.2 cm (8.25-8.75 in) and 43.8-45.1 cm (17.25-17.75 in) right of center (refer to Photograph Nos. 62 through 67). With the child restraint in this forward position, the module cover flap contacted the back of restraint, fracturing the restraint shell during initial deployment. The module cover flap then continued its upward rotation, contacting and fracturing the windshield (refer to Photograph No. 49).

48. Close-up view of a scuff mark on the leading edge of the IP caused by the child restraint.

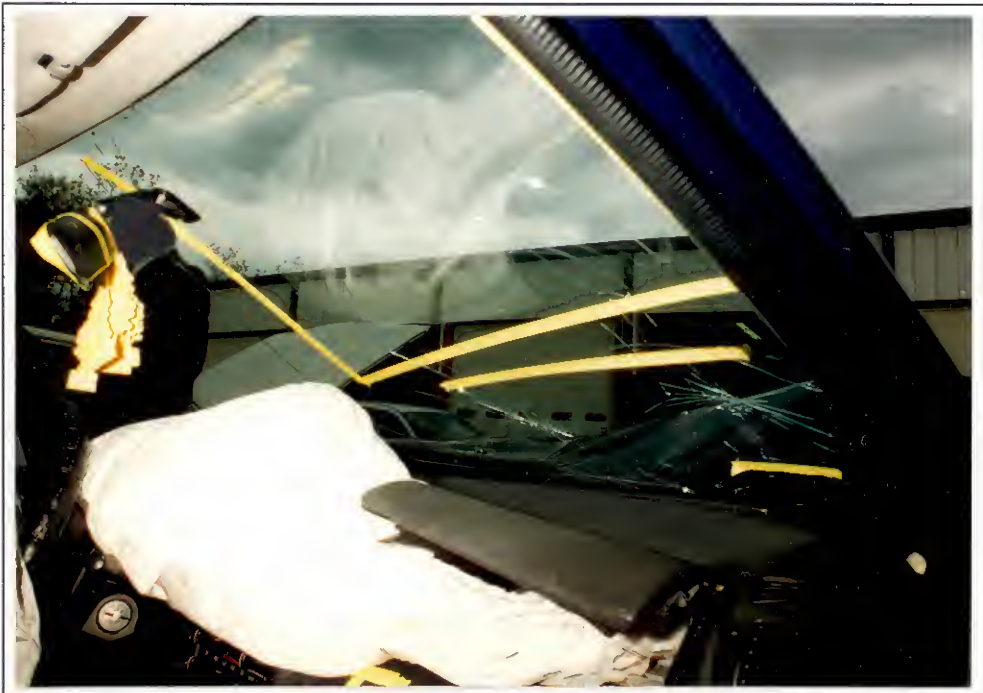
49. Overall view of the windshield fractures caused by the extended module cover.

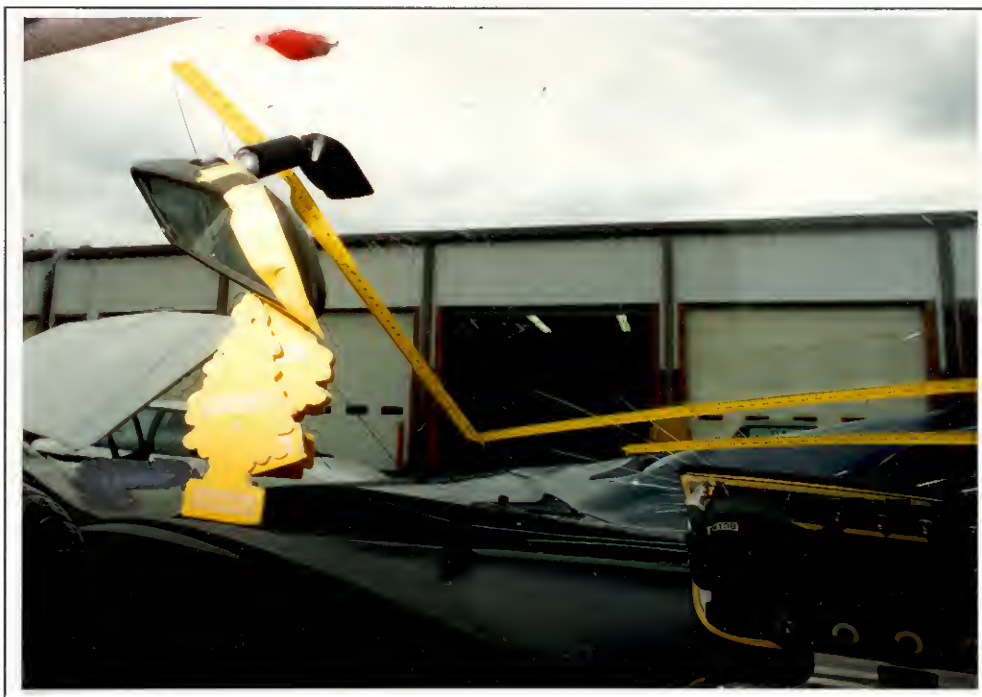
52. View of the fractures in the center of the windshield.

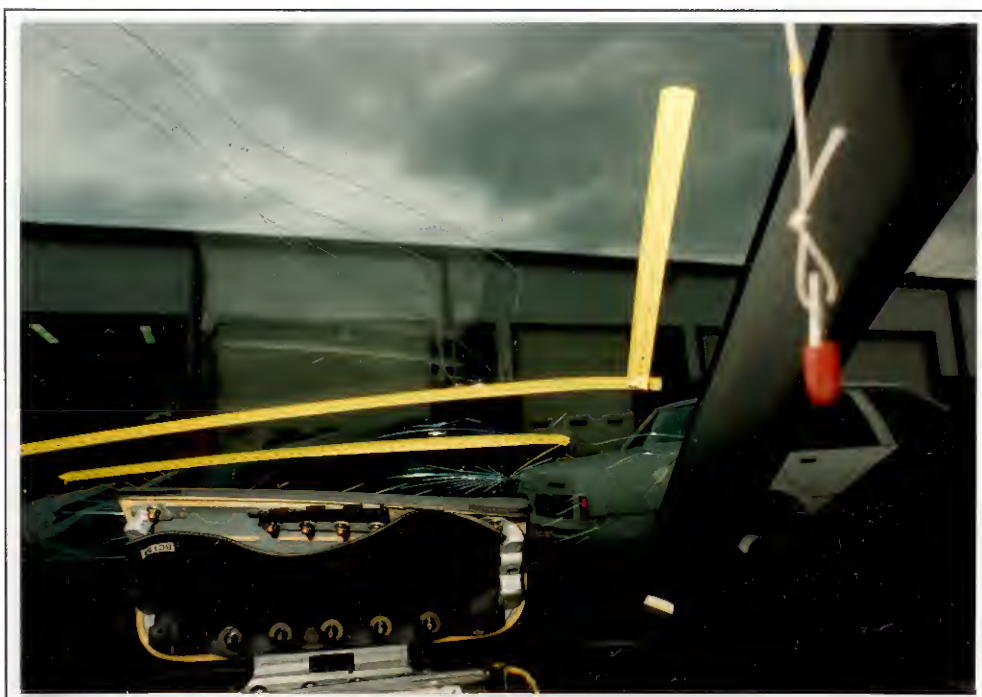
53. View of the right windshield fractures.

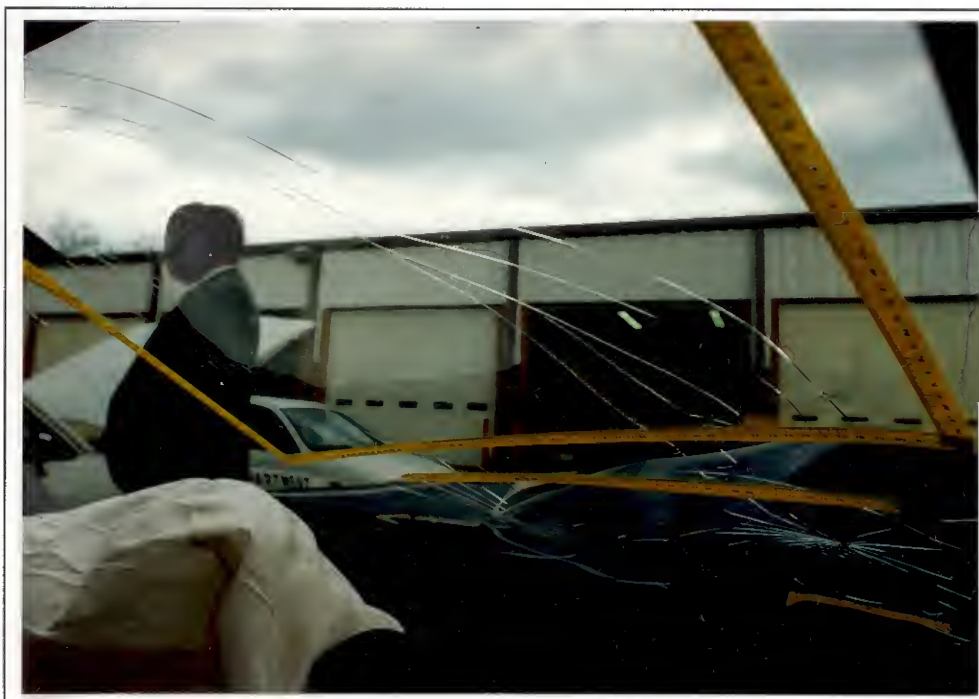
54. Overall view of the windshield fractures.

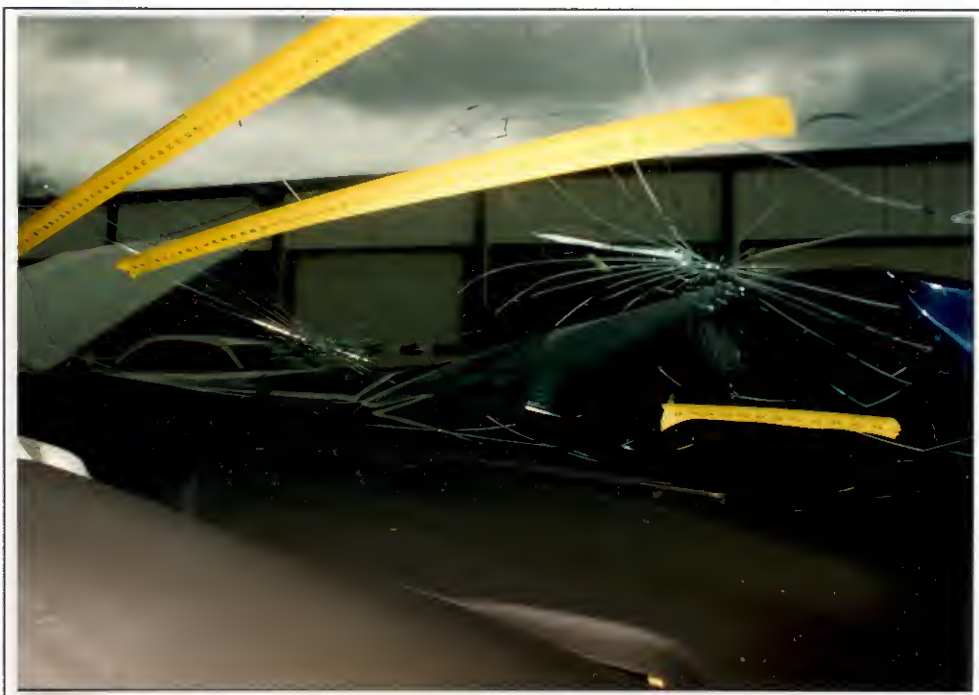
55. Close-up view of the fractures caused by the module cover.

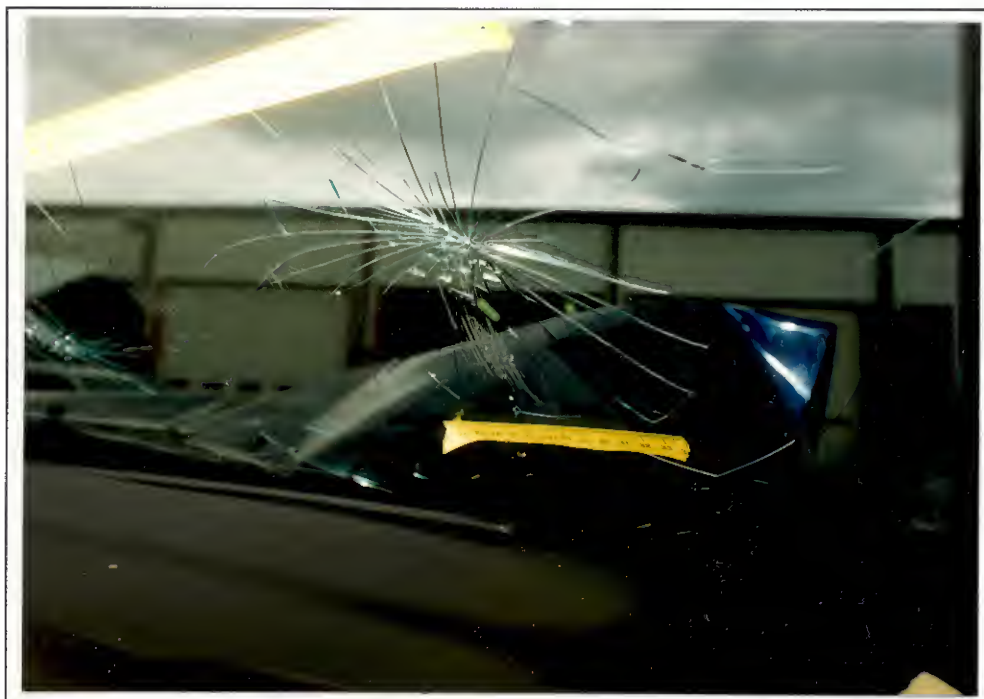
56. Close-up view of the right fracture in photo 55.

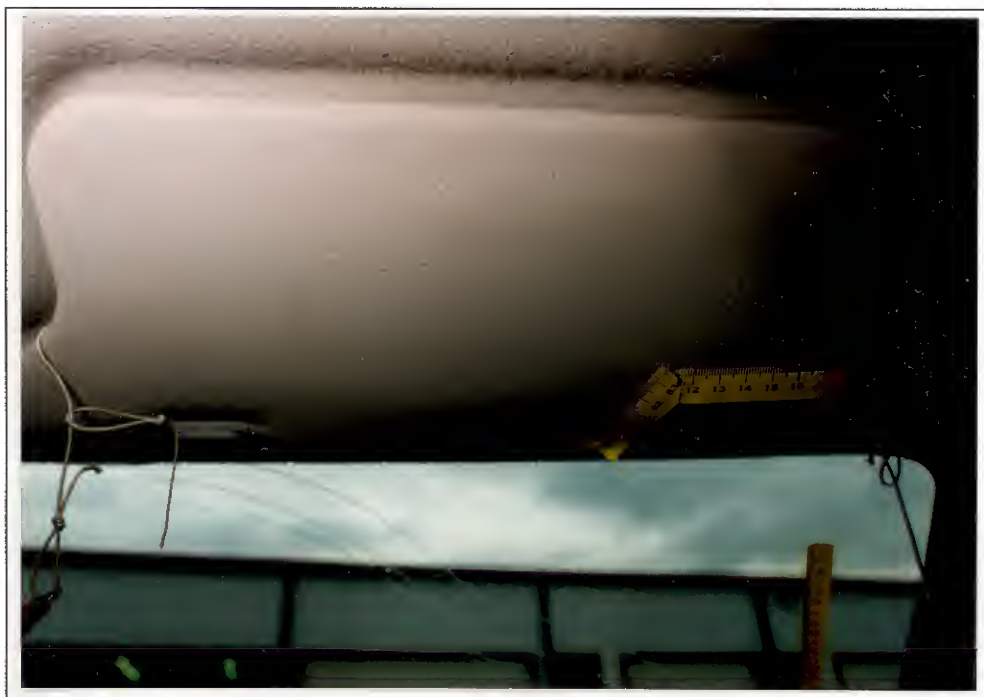
57. View of the stowed right sunvisor and contact to the forward right corner.

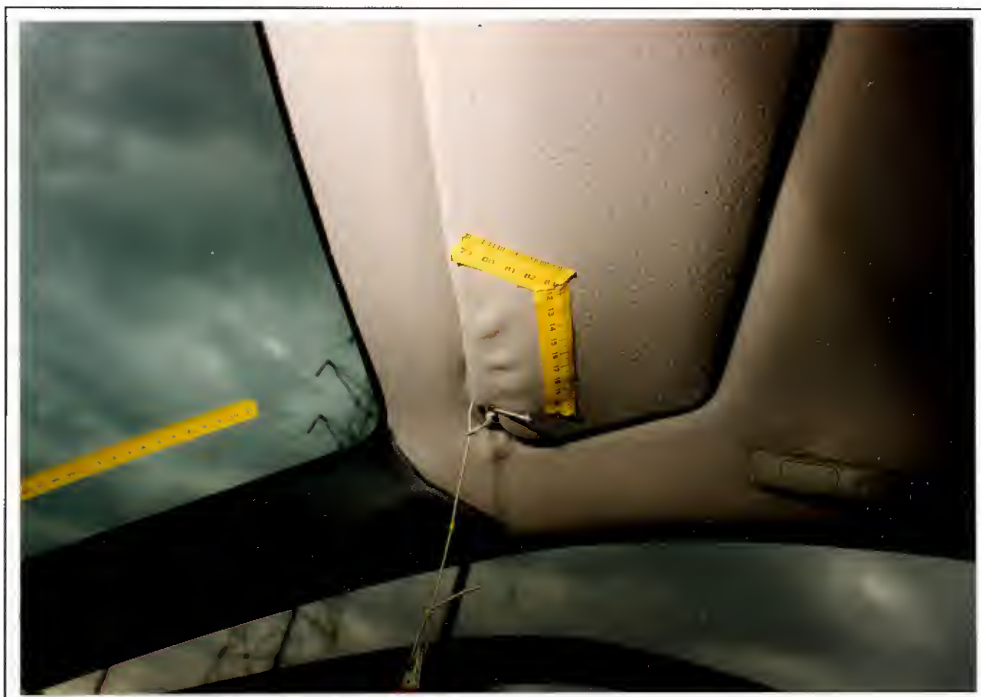
58. Close-up view of the contact to the right sunvisor.

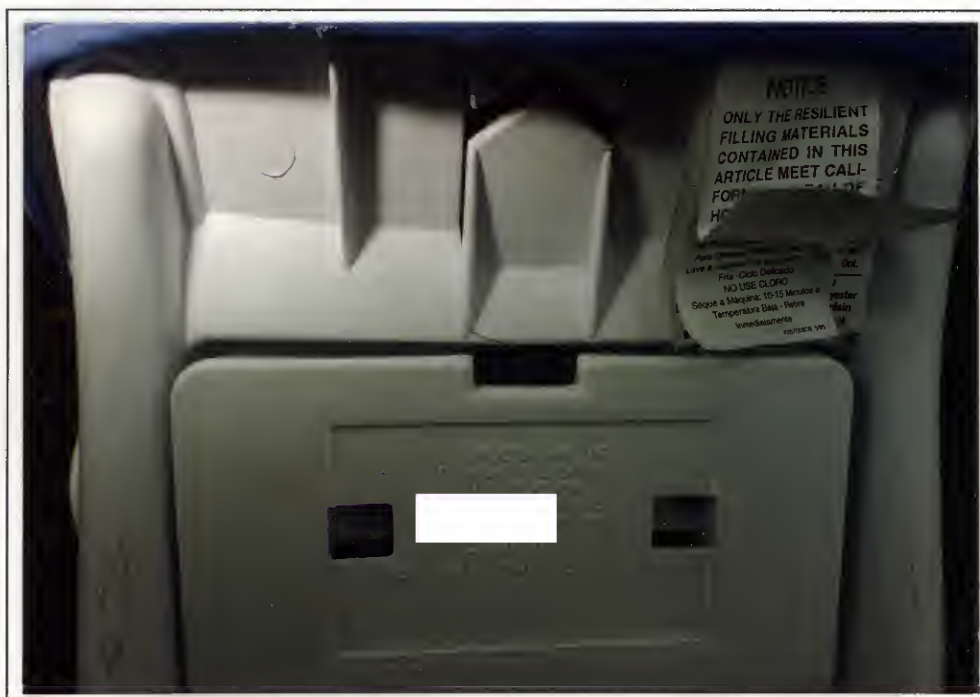
The module cover flap and deploying non-tethered air bag fabric subsequently contacted the back of the child restraint and fractured the plastic shell. Three fractures were documented: the first was located on the upper segment at the top of the compartment door, the second was located at the base of the right outboard vertical reinforcement, and the third was located at the compartment door hinge point. The deployment of the air bag probably displaced the child restraint rearward into the right front seat back. There was no contact evidence to support this sequence. As a result of the air bag deployment, the infant sustained multiple skull fractures (AIS-2) and brain swelling (AIS-3).

79. Overall view of the fracture and contacts to the back of the child restraint.

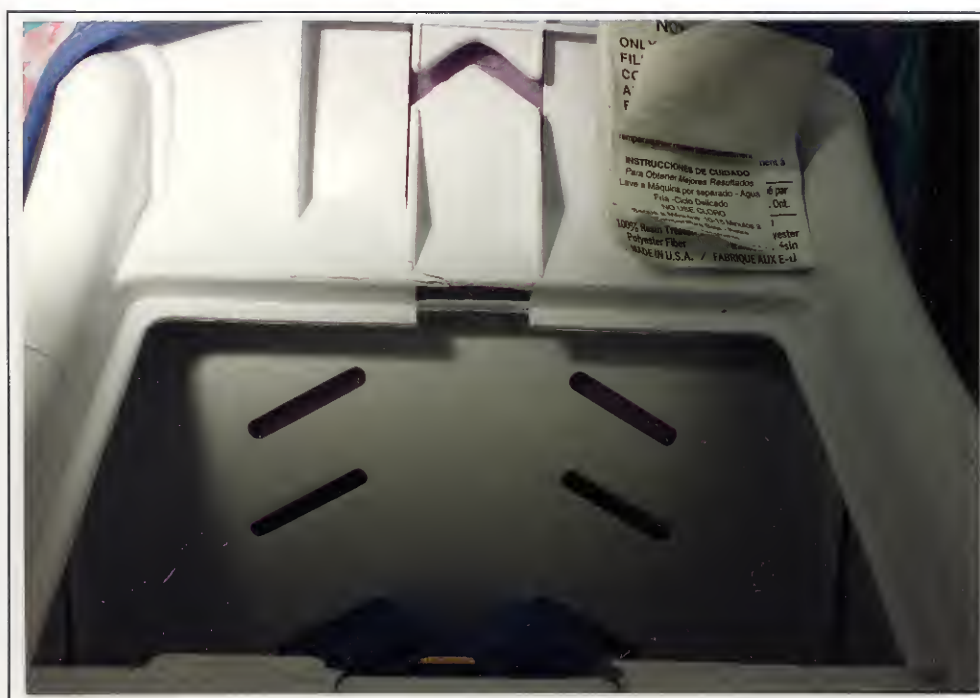
80. View of the fracture of the center back of the child restraint.

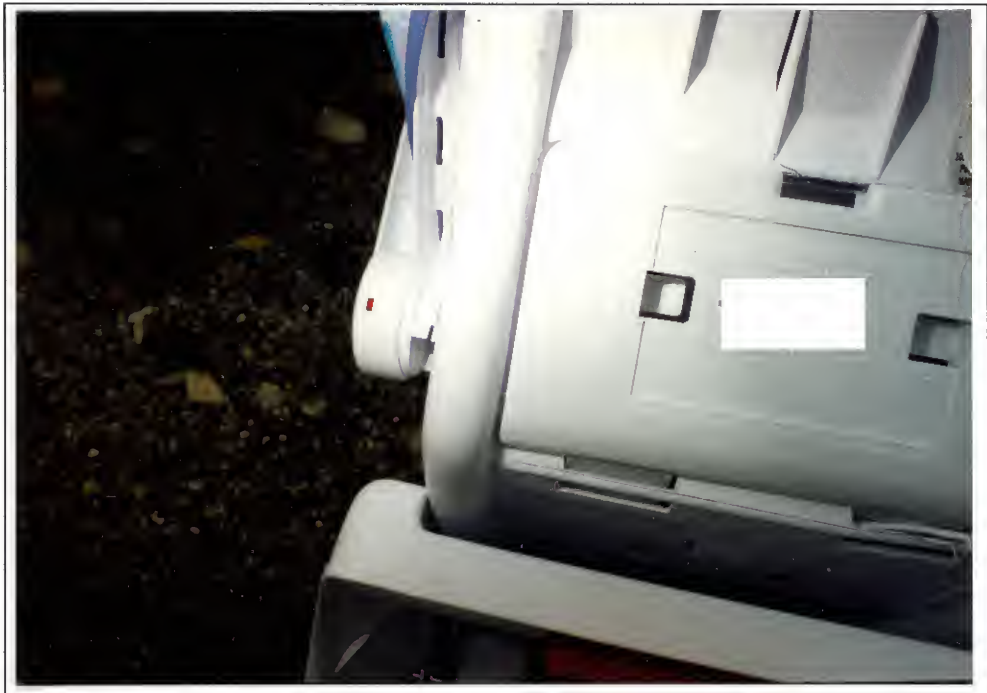
Both rear vertical reinforcements of the restraint had gray vinyl transfers as a result of contact with the right instrument panel during the vehicle's pre-impact braking (refer to Photograph No. 81 and 82). Viewing the child restraint from the rear, the transfer on the left vertical reinforcement was 4.1 x 1.3 cm (1.6 x 0.5 in) and the transfer on the right vertical reinforcement was 3.8 x 1.0 cm (1.5 x 0.4 in). A 3.8 cm (1.5 in) crack in the plastic shell was located at the lower left of the right vertical reinforcement (refer to Photograph No. 83).

81. Close-up view of a vinyl transfer to the left side reinforcement of the child restraint.

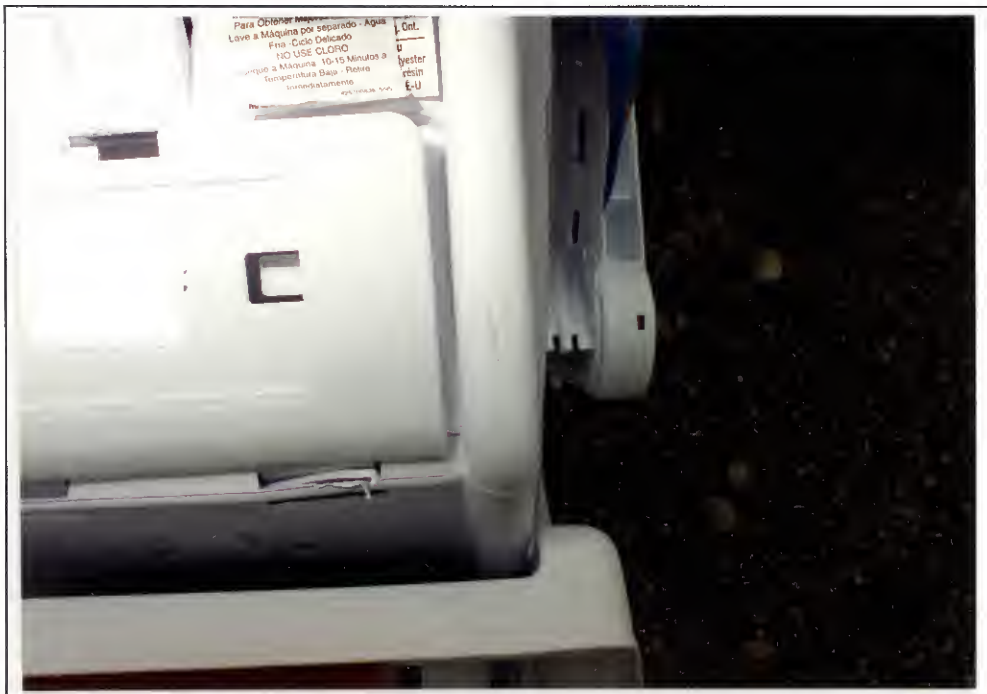
82. Close-up view of a vinyl transfer to the right side reinforcement of the child restraint.

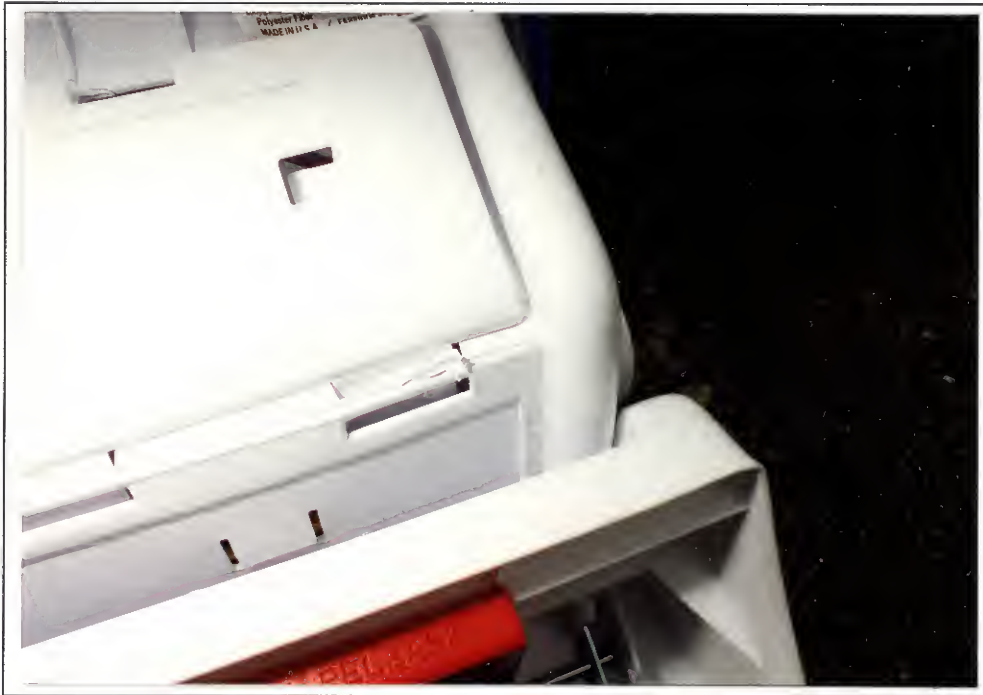
83. View of the fractured hinge of the rear compartment door.

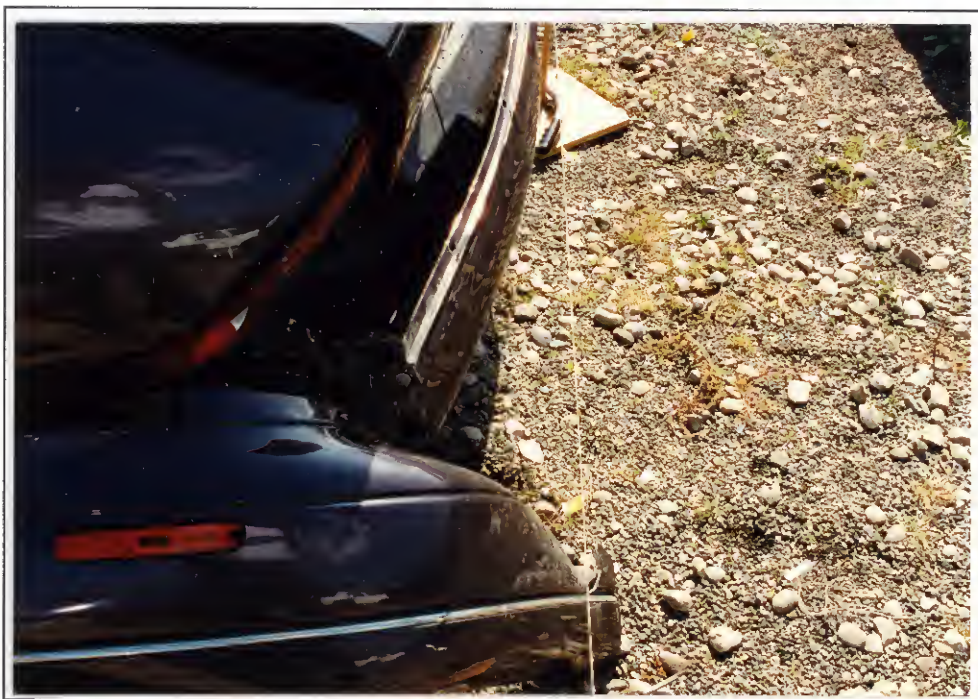
The Monte Carlo sustained moderate damage that resulted from the rear-end impact sequence with the Mazda Protégé'. The rear bumper fascia of the Monte Carlo was separated from the reinforcement bar and fractured. The left corner of the rear bumper reinforcement bar was crushed to a depth of 32.9 cm (13.0 in). The direct contact damage began on the rear bumper fascia 10.2 cm (4.0 in) left of center and extended 59.7 cm (23.5 in) toward the left rear corner.

97. Close-up view of the left rear damage.

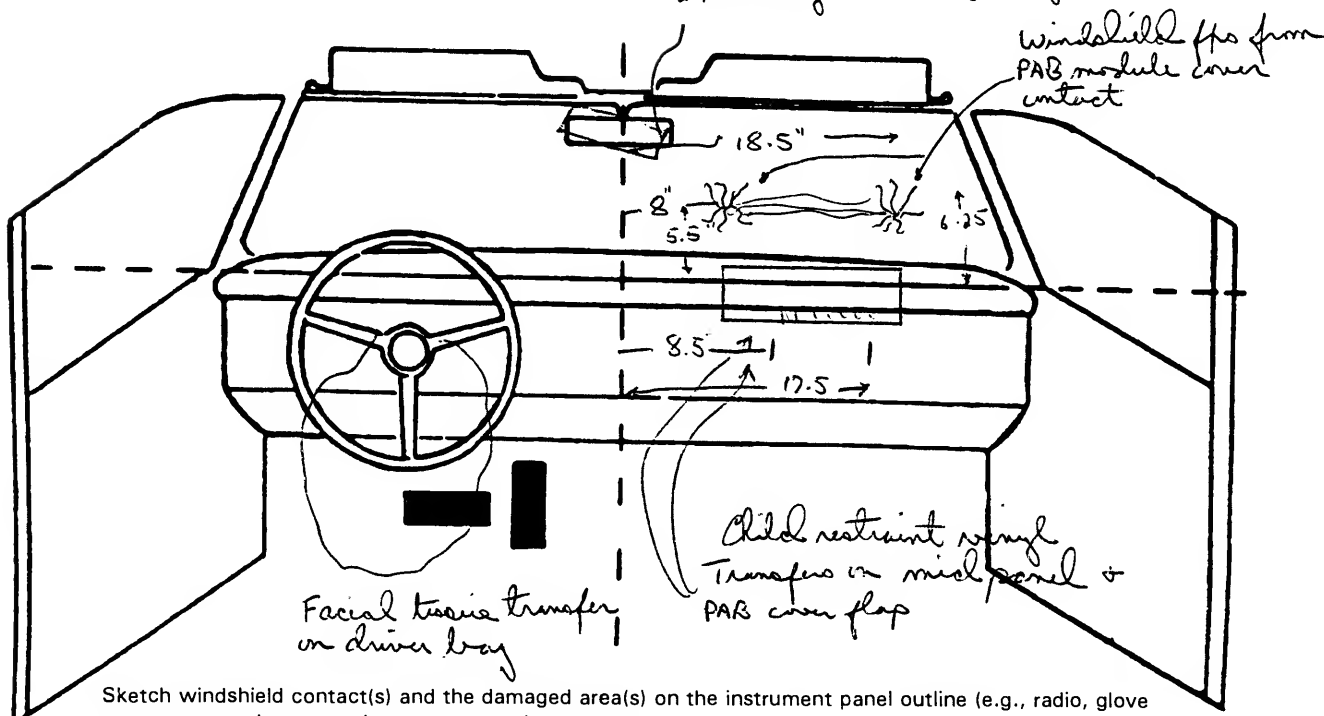
PAB fabric transfer on (R) side of rear view mirror, 2" vertically x 2.5" horizontally

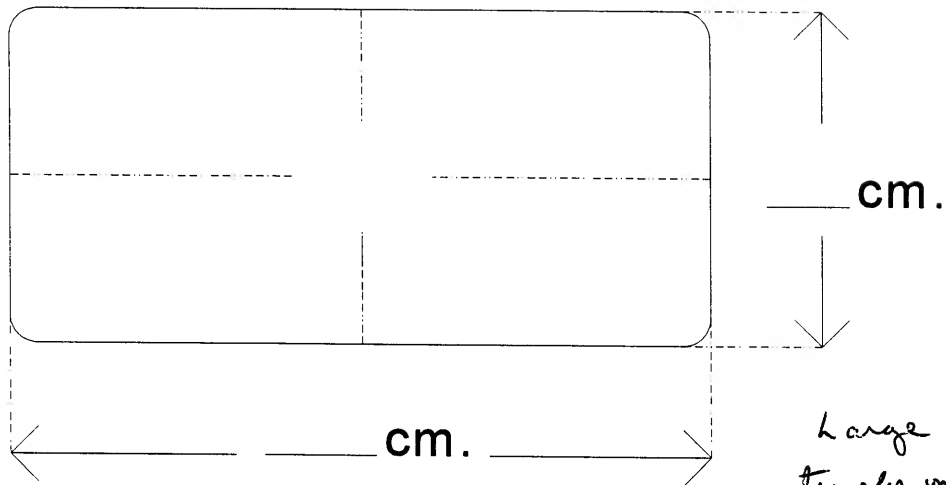
A 30.5 cm (12.0 in) vertical large black vinyl transfer was noted on the right side of the passenger side air bag below the right vent port which began 10.2 cm (4.0 in) out from the inflator. The bottom of the air bag revealed 15.2 cm (6.0 in) vertically oriented blue/green cloth transfers from the child restraint cloth cover. The cloth transfers were located 14.6 cm (5.75 in) rearward of the inflator extending over an area from the right seam horizontally left 19.1 cm (7.5 in). In that same area was a 11.4 cm (4.5 in) wide pattern of gray/black vinyl rubber transfers. The transfers extended 53.3 cm (21.0 in) up onto the bottom face of the bag.

Large black vinyl
transfer on (R) side of
PAB, 30.5" horizontally,
begin 10.2cm outboard
of inflator

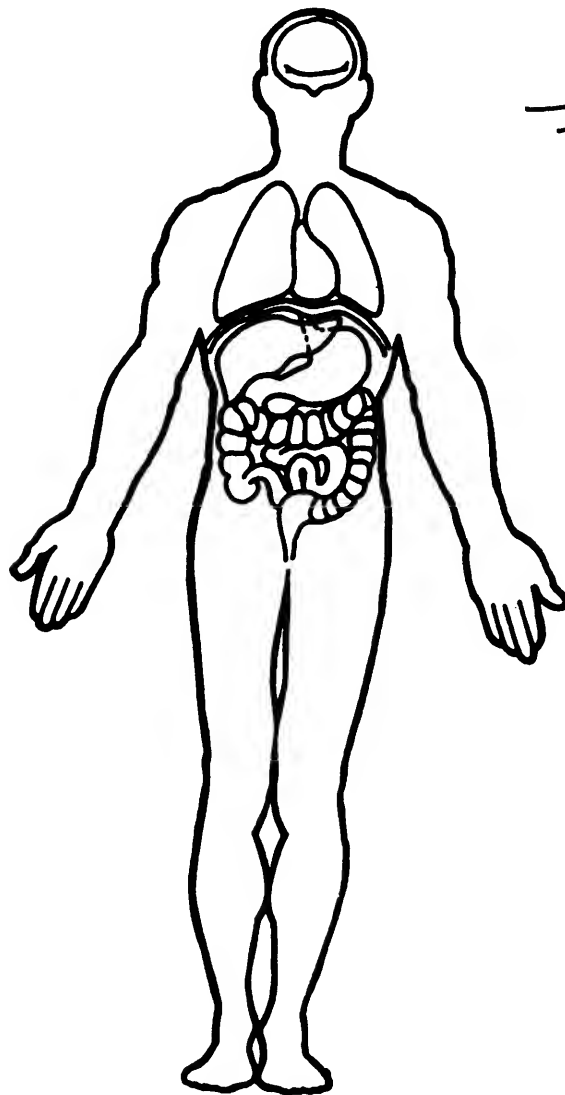
Brain Swelling
Passenger A.R. Bag
